**STANLEY RUNWAY
and the
BLACK BUCK RAIDS
1982**

BACKGROUND

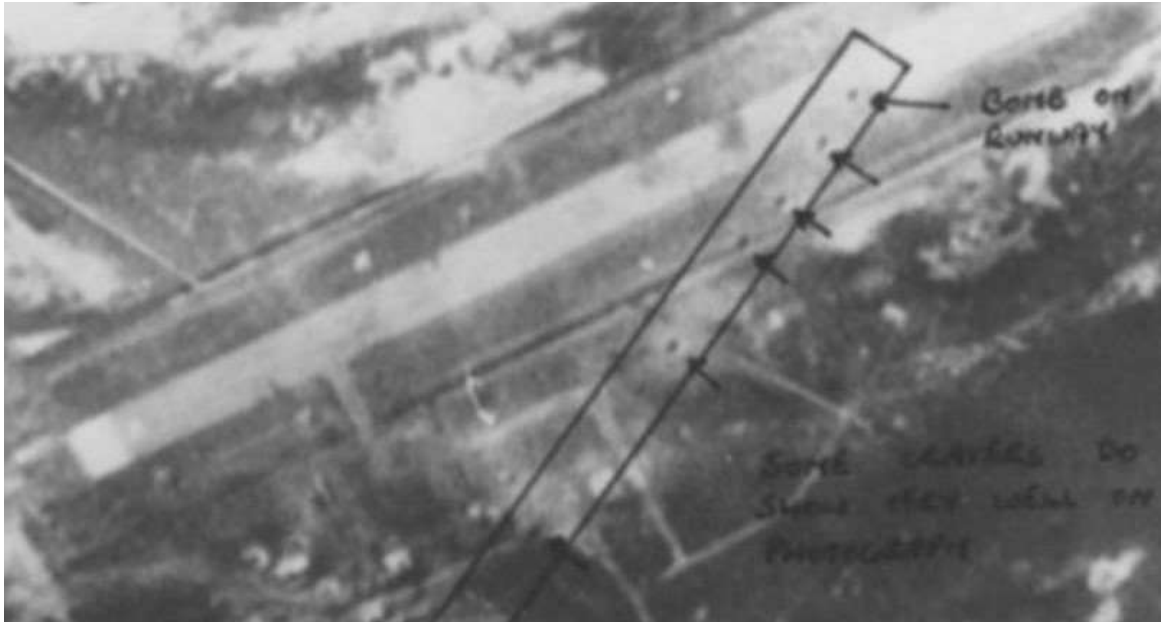
National Archives document AIR 27/3593. Although this photograph is 'attributed' to 'No 101 Squadron (Falklands Conflict)' and is found in RAF Form 549 for 101 Squadron, a rather clearer version was taken by a *Sea Harrier* of 801 Naval Air Squadron on the same day - 1st May (Before Black Buck Two).

4. Although Photograph No 1 appears - on its reverse in Photograph No 2 - to be 'credited' to 101 Squadron RAF, at that time the only aircraft capable of aerial reconnaissance were the *Sea Harriers* of 801 and 800 Naval Air Squadrons.

35. The bomb on the southern half of the paved runway in Photographs Nos 1 and 2 has disappeared in No 6 and in its place there would appear to be a faint white ring clipping but not straddling the centre-line. Yet the bomb crater in Photograph No 1 clearly straddles the centre-line. Thus it must be concluded that some manipulation of the 'RAF photograph' has taken place.

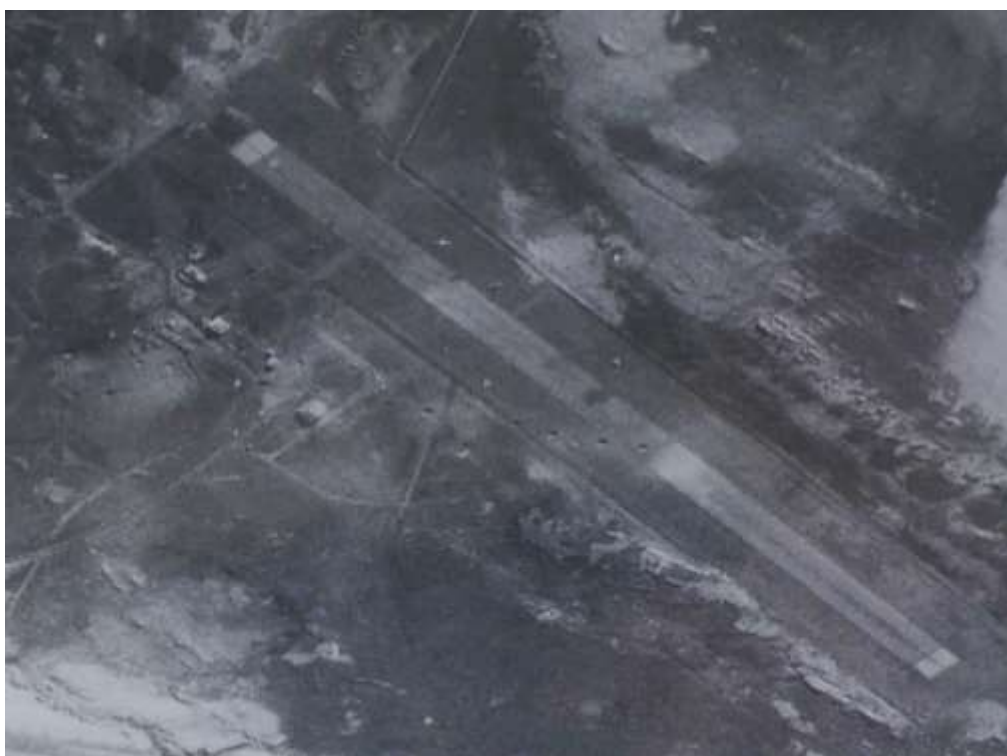
Photograph No 3
Taken on the 1st May. National Archives DEFE 69/844 HMS *Invincible*: Falkland Islands Campaign Dairy

28. Photograph No 3 was taken before the Argentines would have had time to muster the resources required to fill in or alter any crater. The first bomb to land hit the southern half of the runway, the second bomb crater clipped the runway as can be seen clearly. In a comparison with the RAF-sourced Photograph No 1, also taken on 1st May, a distinct difference is immediately obvious: in No 3, whose origin is undoubted and whose clarity is obvious, the first crater is off the centre-line but in No 1 (which comes via the RAF's 101 Squadron and whose fuzziness is evident) the first crater is central and the photograph has been notated with an overlay.

30. Having analysed FAA Photograph No 3 Admiral Woodward [CTG 317.8] sent a signal to Admiral Sir John Fieldhouse [CTF 317] in Northwood on the 2nd May [Signal No 1] which was then repeated by Admiral Fieldhouse to the MOD with a description of the battle damage as far as could be ascertained from the photograph.

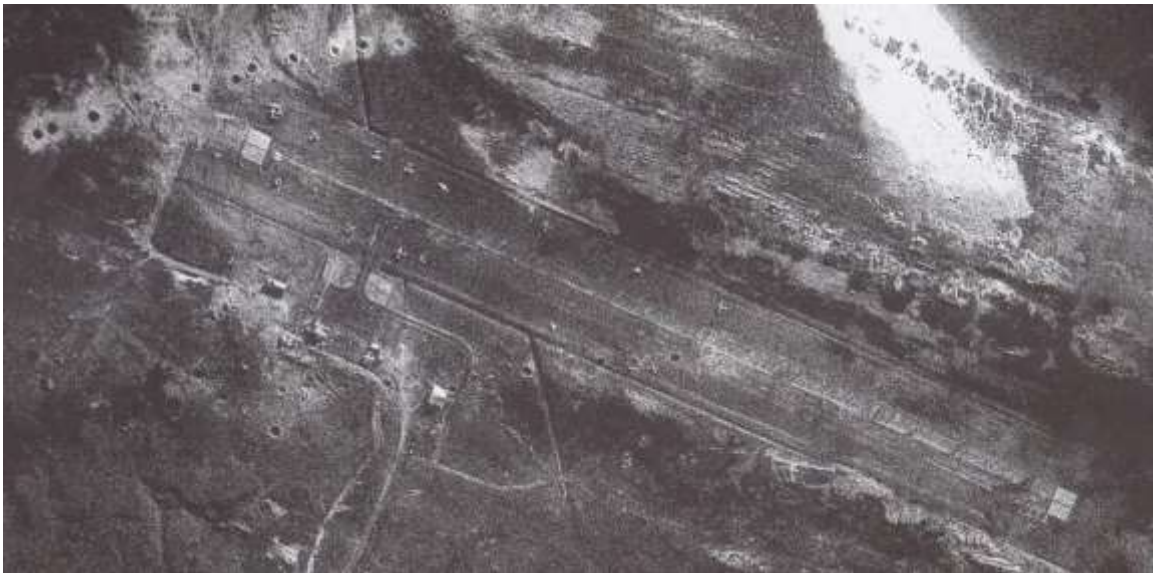
Photograph No 6
Taken on 4th May by 801 Naval Air Squadron following Black Buck Two

34. A second Black Buck raid took place over the night of 3rd/4th May with all the bombs missing the western end of the runway. Within hours of this second bombing mission an aerial photograph (Photograph No 6) was taken by Lieutenant Cantan in a *Sea Harrier* from 801 Naval Air Squadron. This not only shows the Black Buck Two bombs that missed the runway but also the Black Buck One bomb crater just off the south side of the paved runway and about halfway along as seen in Photograph No 3. This photograph No 6 was processed and analysed within an hour or so of Cantan landing back on board HMS *Invincible*. Its origin and authenticity have never been queried. Yet this photograph also differs when compared with Photograph No 1.

37. Photograph No 6 is also the photograph used by *Wikipedia* and **which no one has seen fit to replace.** [Our emphasis.]

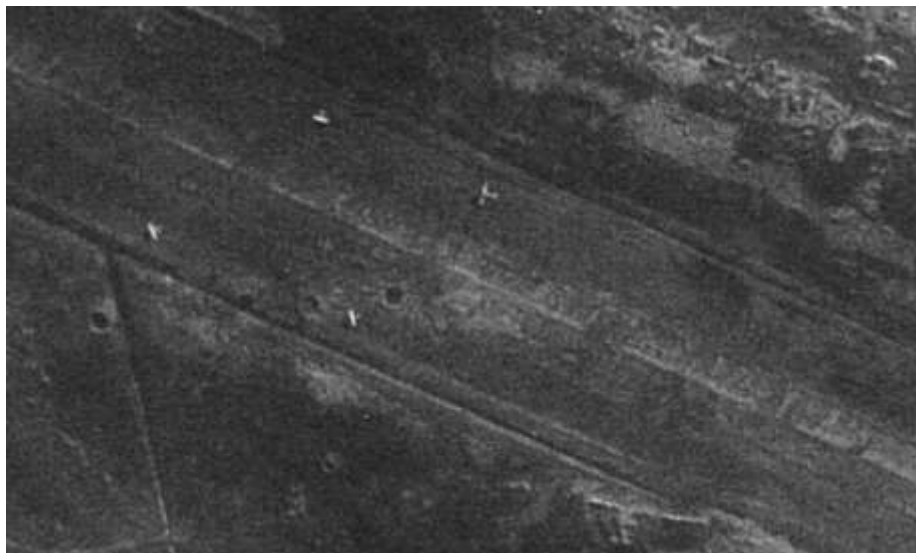
Photograph No 7 – enlarged from No 6

38. Photograph No 7 is an enlarged version of No 6 from which it is even more clear that there is one crater clipping the southern edge of the paved runway and no other extant crater on the runway following Black Buck One. The white circle towards, but not straddling, the centre-line is hardly visible. This suggests that the crater had been filled in.

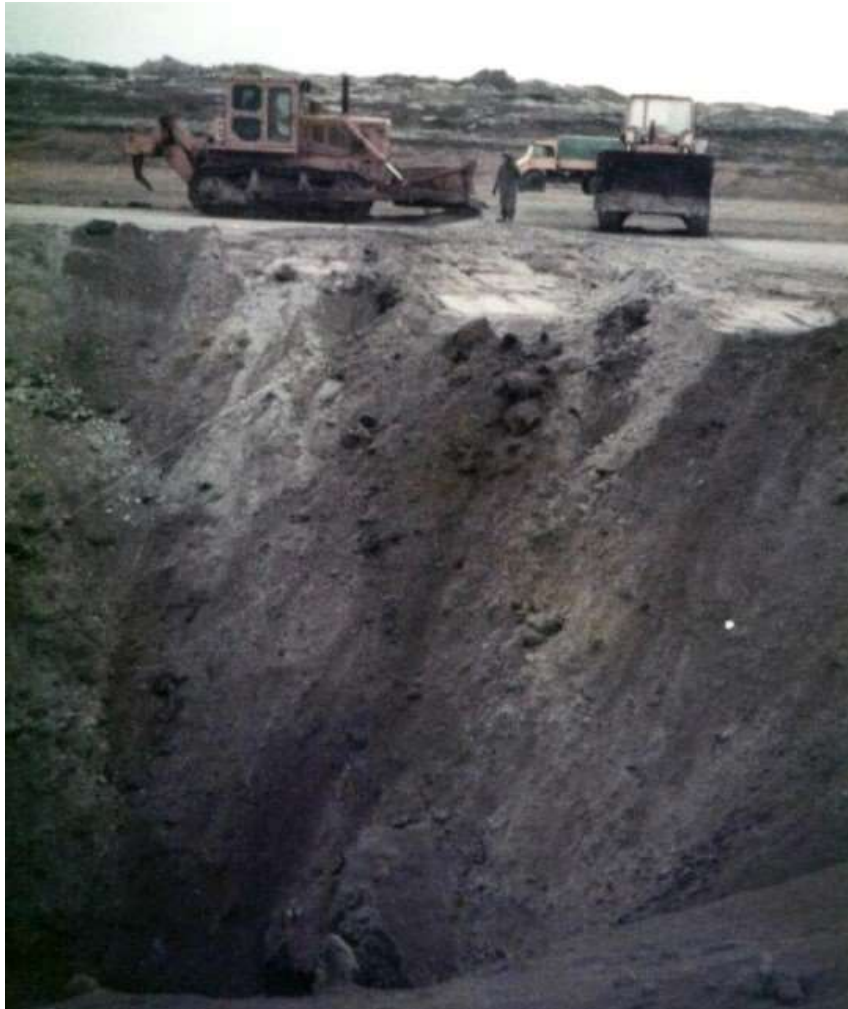
Photograph No 9
Taken on 4th May by General Mario Menéndez

41. In Photograph No 9 the paved runway is beyond the vehicles. This north-facing photograph, coupled with General Menéndez’s accompanying description, offers evidence that this crater is not on the paved section of the runway. The runway was constructed of 12 inches of crushed stone on a sand base, covered by four inches of concrete (then overlaid with asphalt, although this has to be confirmed). There is not much sign of that in this photograph. Either side of the paved runway the surface was hard packed earth topped with rough grass. These two strips each 180 feet wide along the runway’s full length were suitable for (although not constructed for) parking and the taxiing of light aircraft.

42. In an exchange of e-mails with Southby-Tailyour in 2013 the general confirmed that the photograph that he had taken of the crater was just clipping the edge of the paved runway and was the first bomb to hit: he made no mention of bombs either side of the runway or in the middle although he admitted that much rubble was spread unevenly across the paved area towards the centre-line. His statement is, though, at odds with that of Brigadier Luis Guillermo Castellano, Commander Air Group Malvinas. [See Paragraph 66]. As will be shown this rubble was enhanced to fool the British in an action described enigmatically by the general as: *Consequently, much subterfuge.*

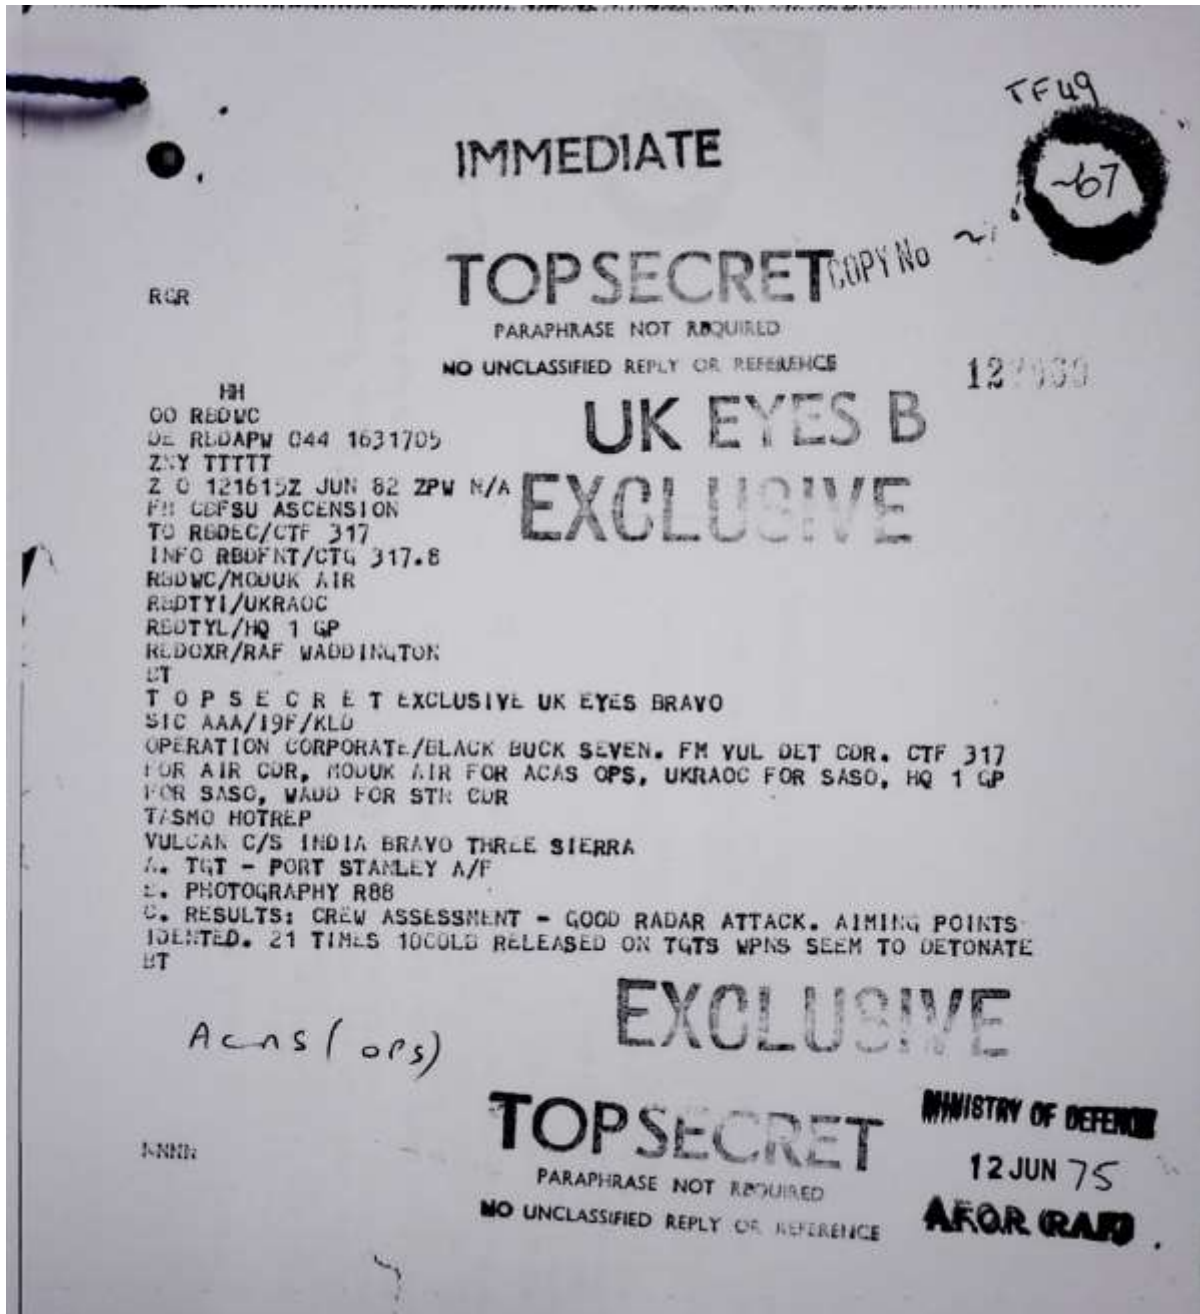
Signal No 5

47. On 12th June a signal (No 5) was sent from Ascension Island to the C-in-C at Northwood offering an optimistic *crew assessment* of the damage caused and stating that all bombs had *seem* to have detonated on target.

SIC 19F/KLD
 OPERATION SUTTON/BLACK BUCK
 4. CBF09 AAA/19F/KLD 121935Z JUN 82 (NOTAL)
 6. CTU 317-1.1 19H 122104Z JUN 82 (NOTAL)
 1. PR LIMITED BY CLOUD HOWEVER NO FURTHER DAMAGE OBSERVED. SUSPECT MISSED TGT.
 2. FOR 317.1.1. PREVIOUS PR SHOWS AT LEAST 5 DAMAGED AC IN AREA PLUS 2 POSS DUMMY SHEPT WING AT EAST END OF STRIP
 BT

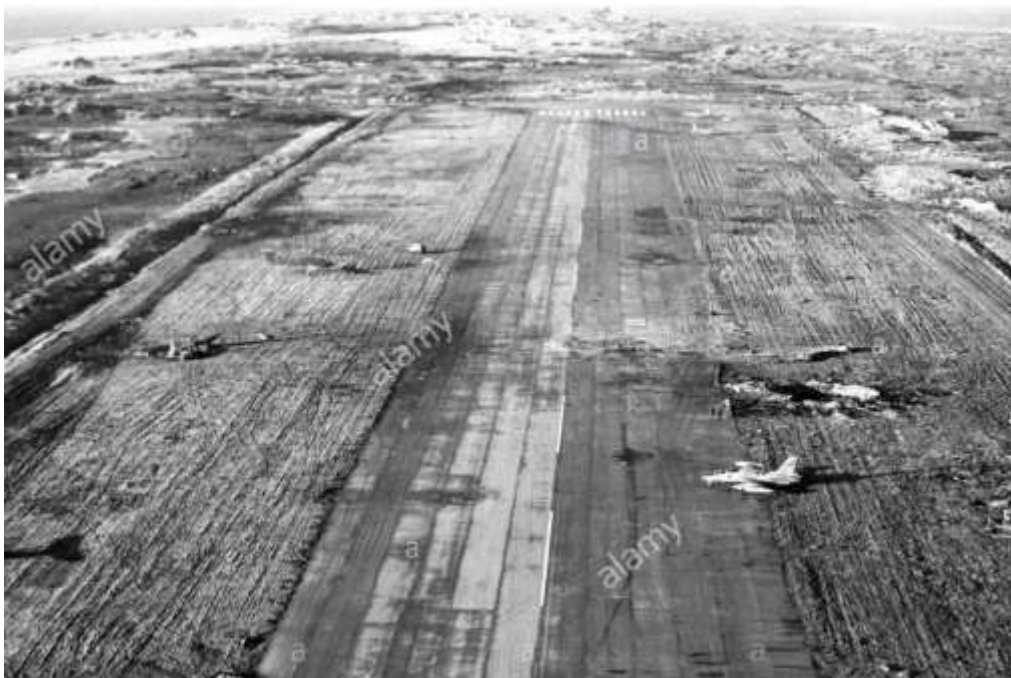
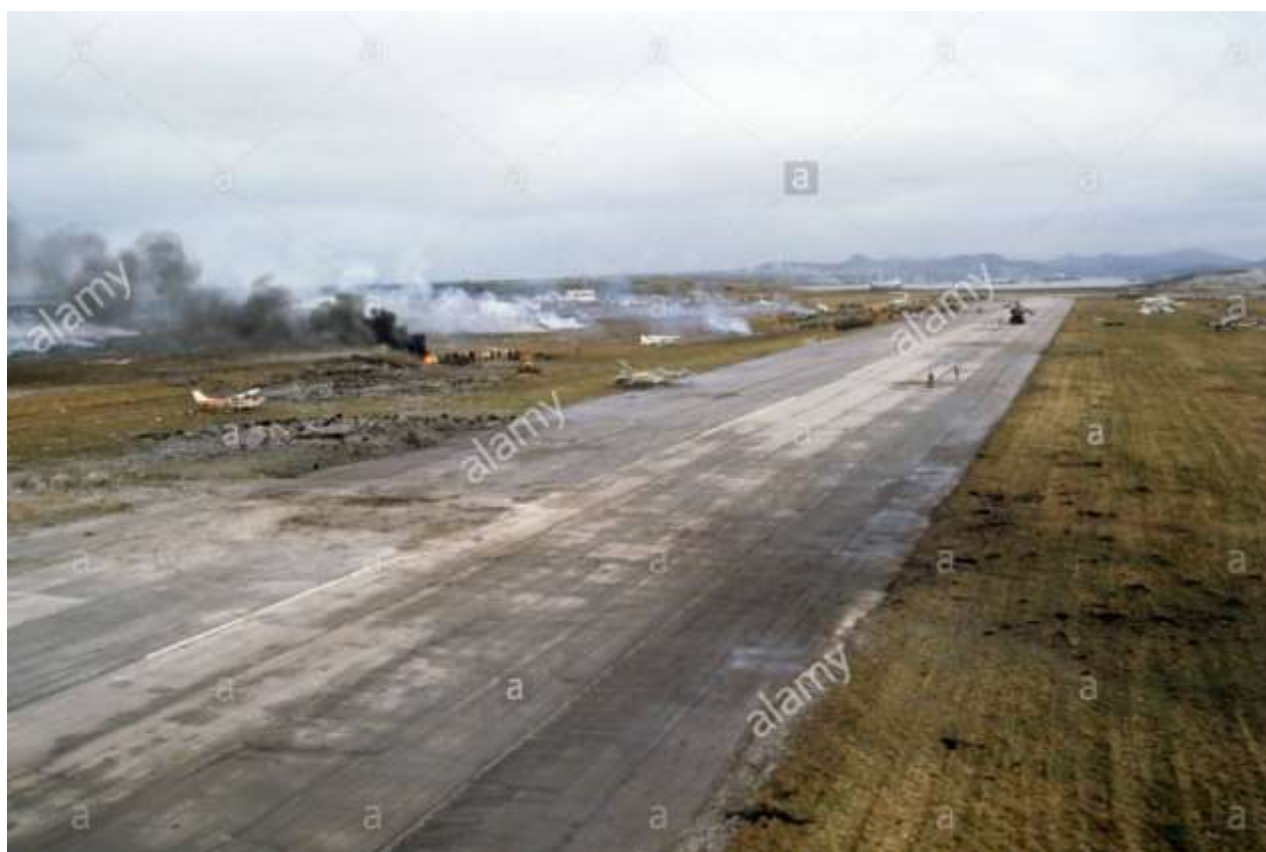
Photograph No 11
Although watermarked by Alamy this was taken by the AAF on 7th June

Photograph No 12
Although watermarked by Alamy this was taken by the AAF

68. In Photographs Nos 11 and 12 the crater that clipped the southern edge of the runway is clear. There is no hint of a crater straddling the centre-line.

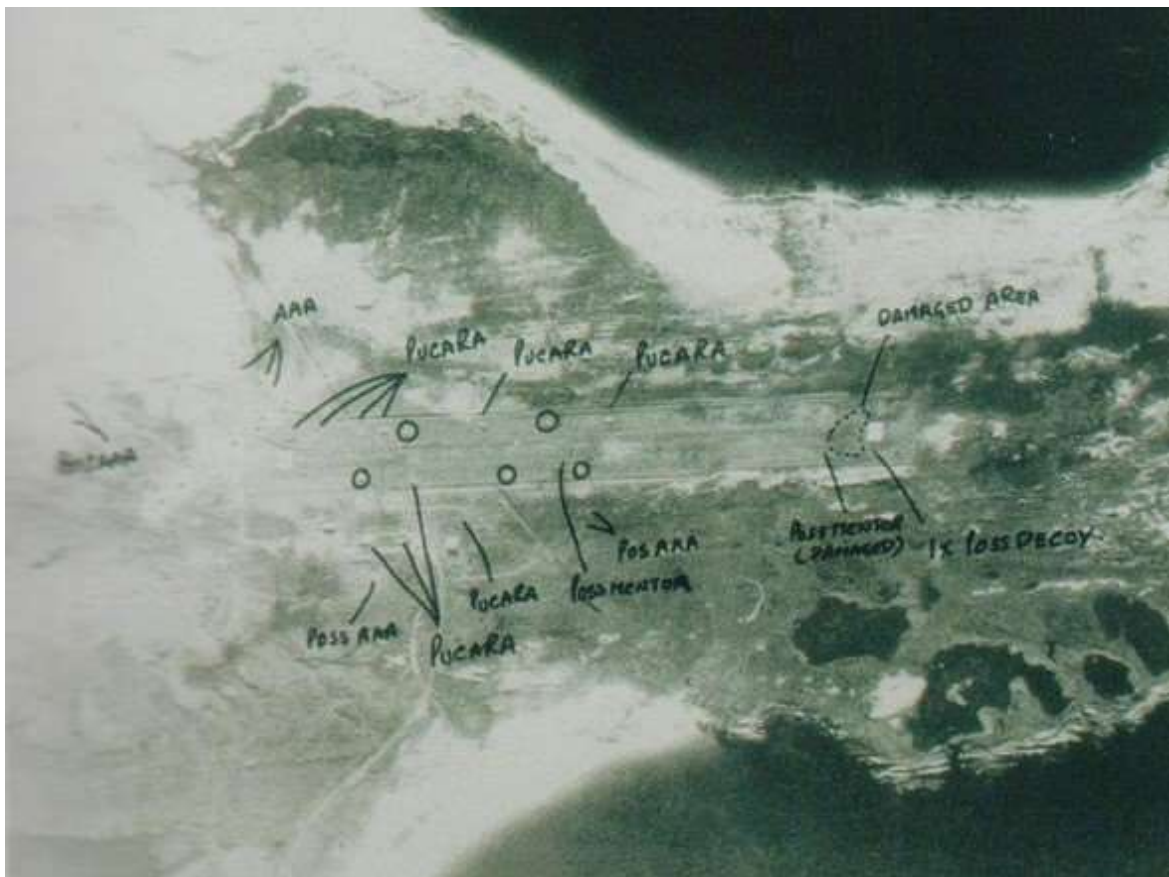
74. It goes on to display a photograph of unknown origin that shows a number of damaged areas none of which are on the main runway. Photograph No 13 has this caption:

Aerial photos of the Falklands aerodrome in an attempt to take stock of the raids. Despite the tons of bombs the ‘piste’ remained usable until the end of the conflict.

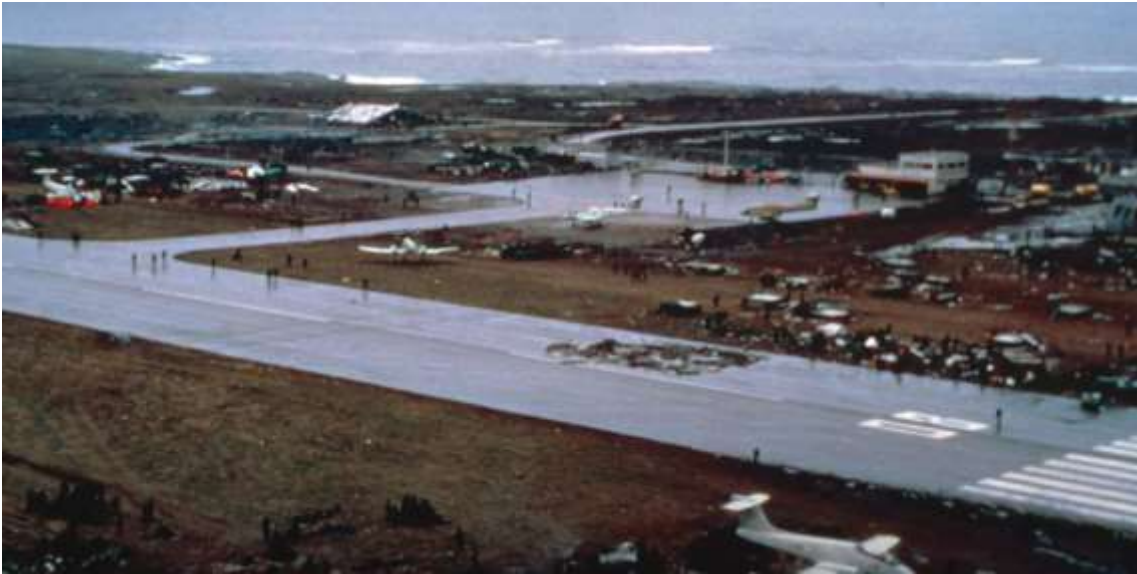
Photograph No 14
Credit AAF

93. Photograph No 14 has been used by others to show that a 'Vulcan's bomb hit the runway'...but this is not a 1000 lb bomb crater but rubble, as mentioned by Commander Gedge and Lieutenant-Colonel Blundell, on the western end of the runway. It's juxtaposition with the control tower indicates its position as being to the north-west whereas the one bomb that clipped the runway was to the north-east. Even if this is not rubble then the only other credible explanation is that it is damage by a *Sea Harrier* and was easily repaired before Alberto Vianna landed his *Hercules* along the northern side of the runway.

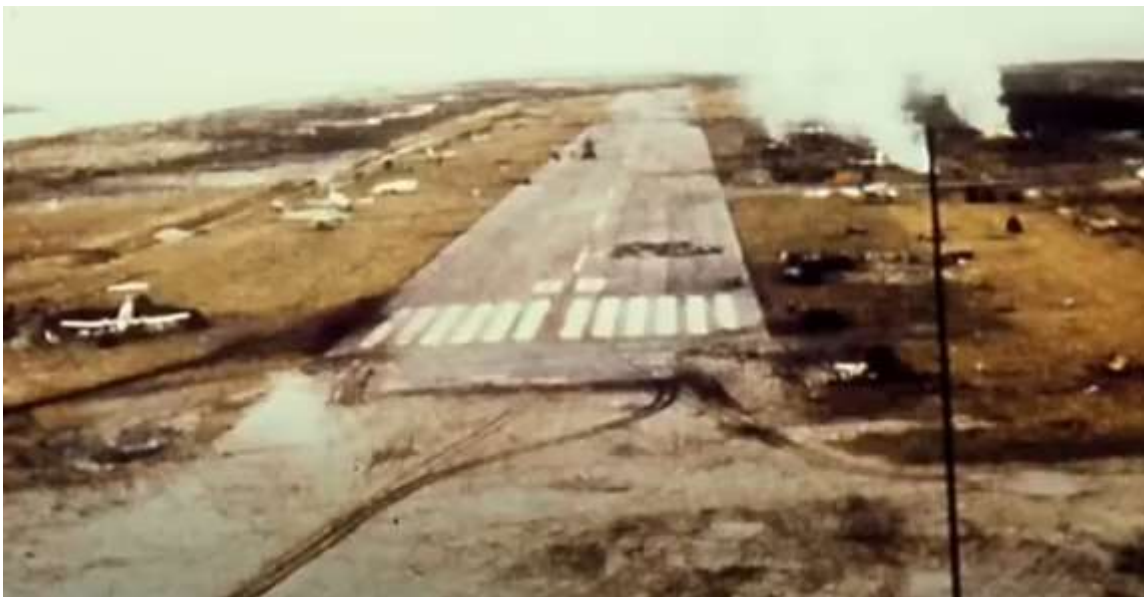
Photograph No 15
Credit AAF

94. In Photograph No 15 of the whole runway, the bomb that clipped the paved portion can just be seen on the right in the distance but no sign of anything towards the runway's centre as it either did not happen or was placed there by the Argentines - or it had already been repaired. There is no hint of a centre-line crater. The dummy rubble is clear in the foreground on the right side of the paved area.

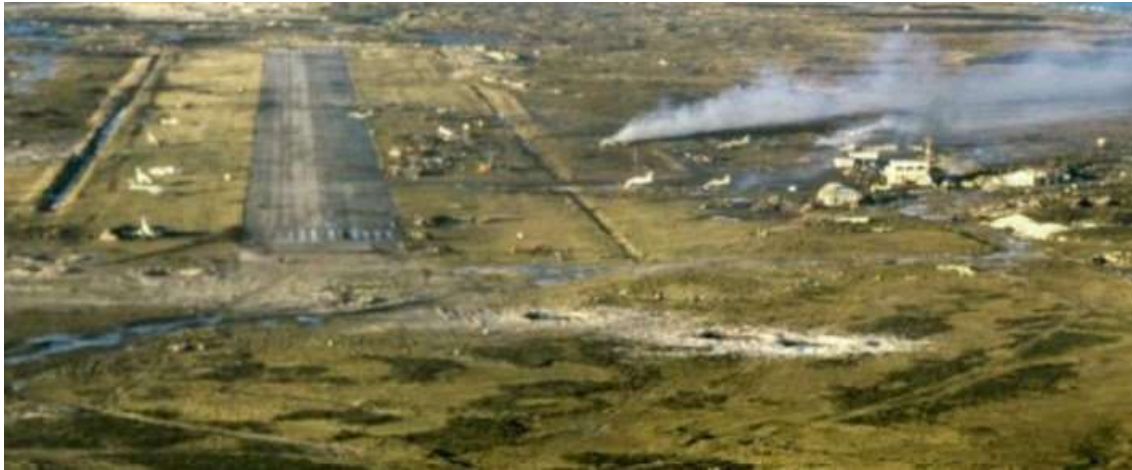
Photograph No 16
Credit AAF

95. No sign of any significant runway damage in Photograph No 16 taken before the end of hostilities.

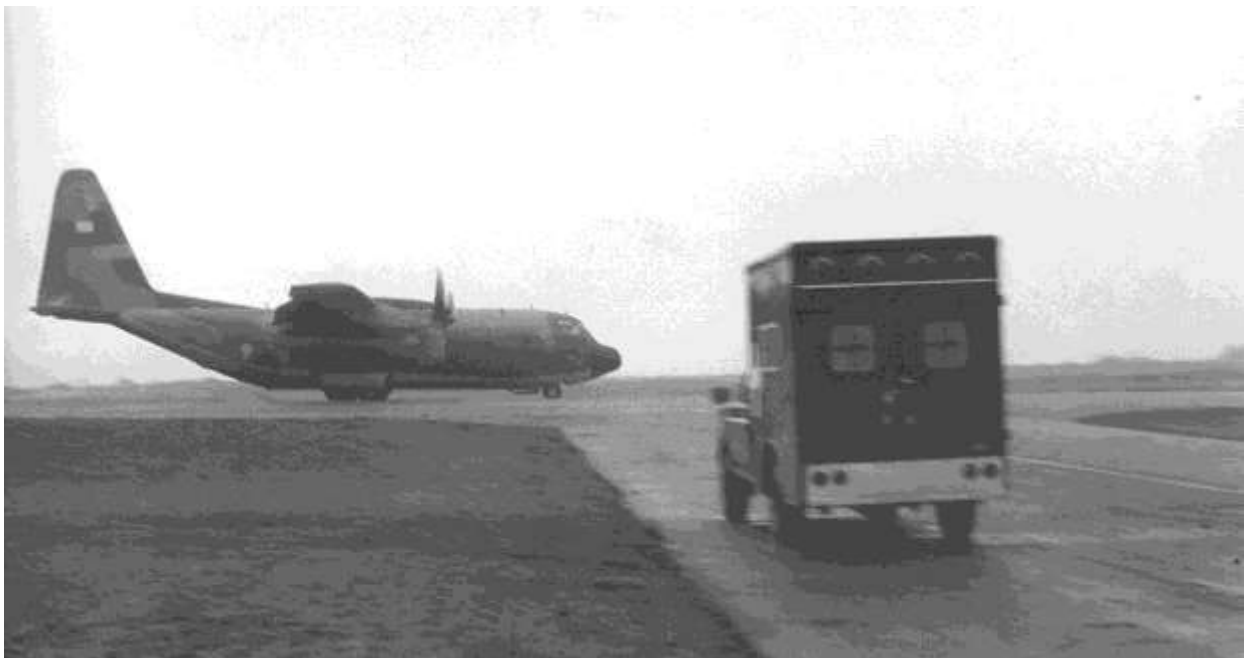
Photograph No 17
Credit AAF

Alberto Vianna taking off safely towards the east in his *Hercules* TC-65 on 6th May along a clean-looking section of the runway (being chased, in vain, by a late ambulance!).

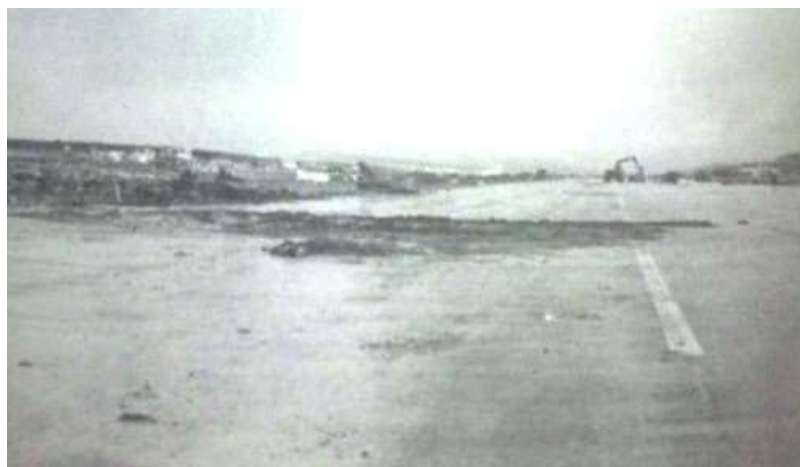
98. In Excerpt No 3 (below) we show the only photograph we have seen of a close up, ground view of the one crater on the runway. The main crater can be seen towards the left with rubble spread (we believe, from Argentine statements) by hand towards the centre-line.
